# Nelson Lagoon Hazard Impact Assessment

Prepared For:

HDR Alaska, Inc.  
with  
Shannon & Wilson

October 2011

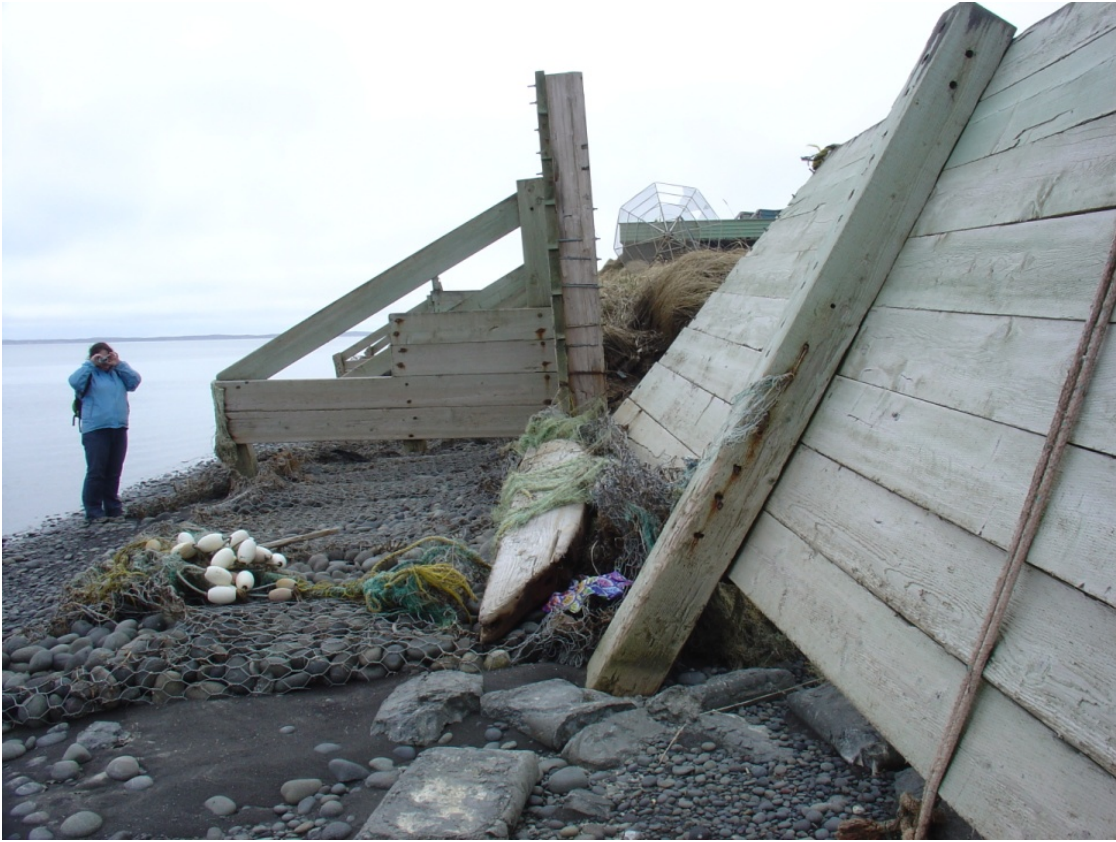
**Figure 17. Undermining and Removal of Material behind a Portion of the Timber Sea Wall in the Southeastern Portion of the Community**

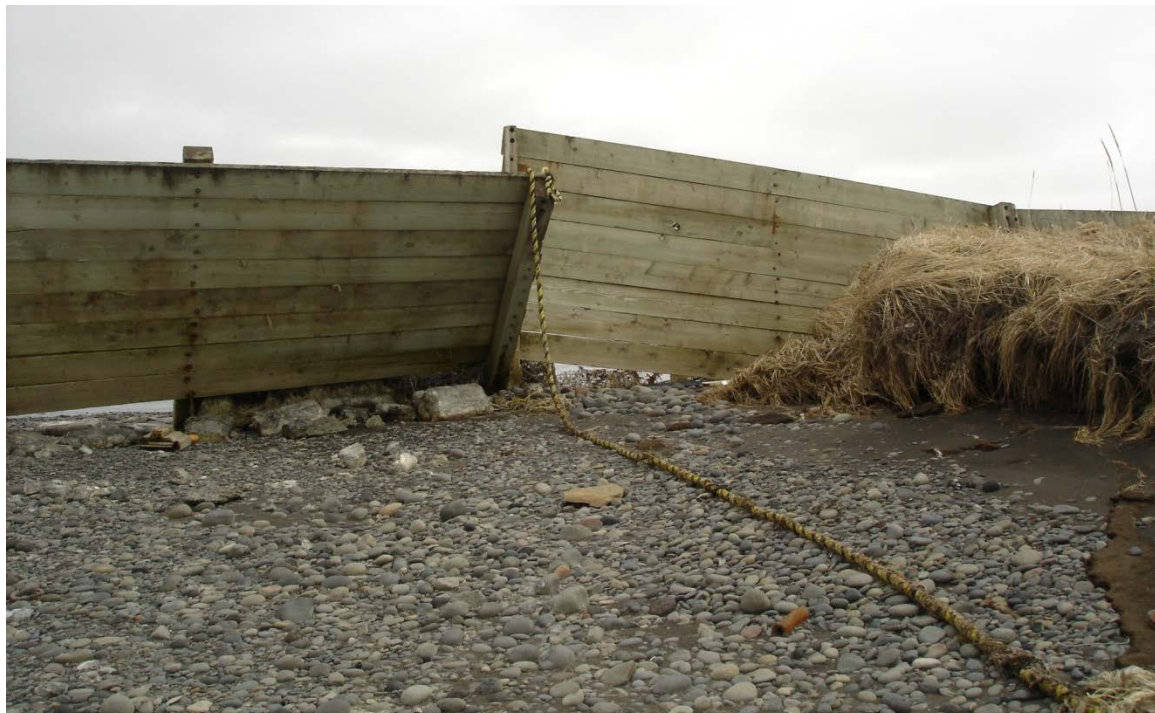
**Figure 18. Damage to Wooden Seawall**

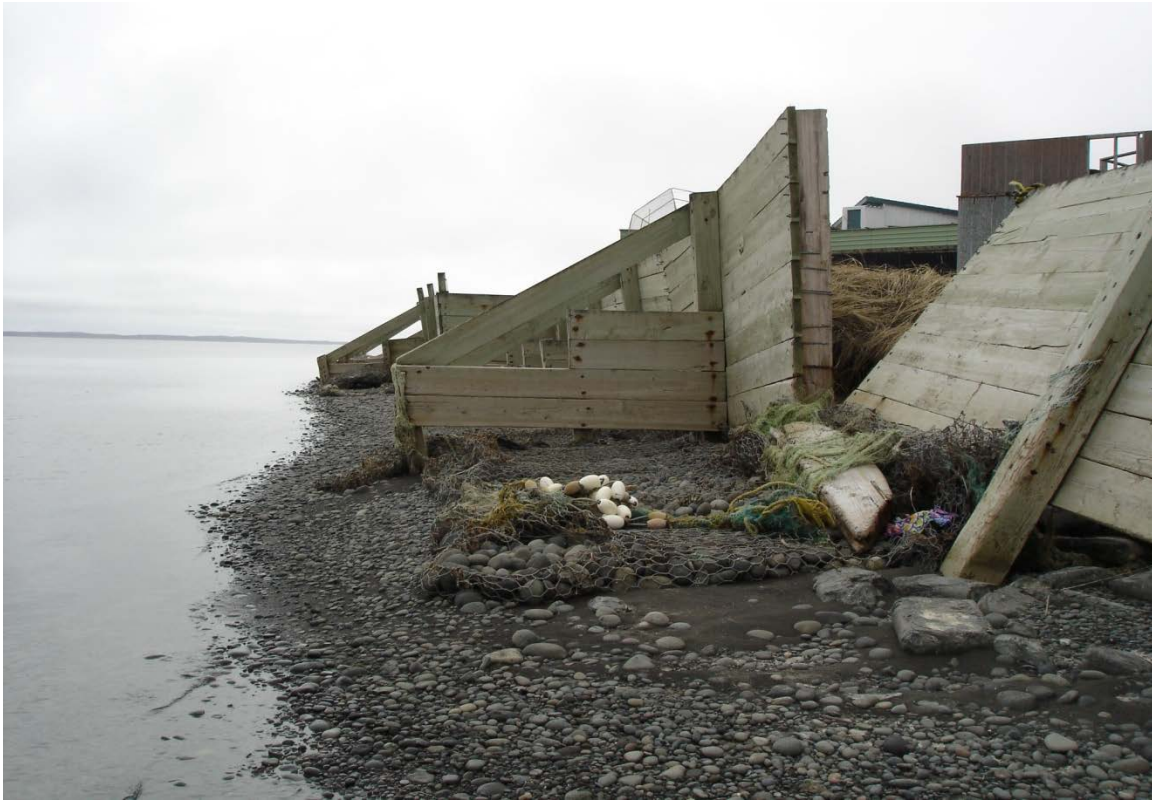
**Figure 19. Broken Section of Wooden Seawall**

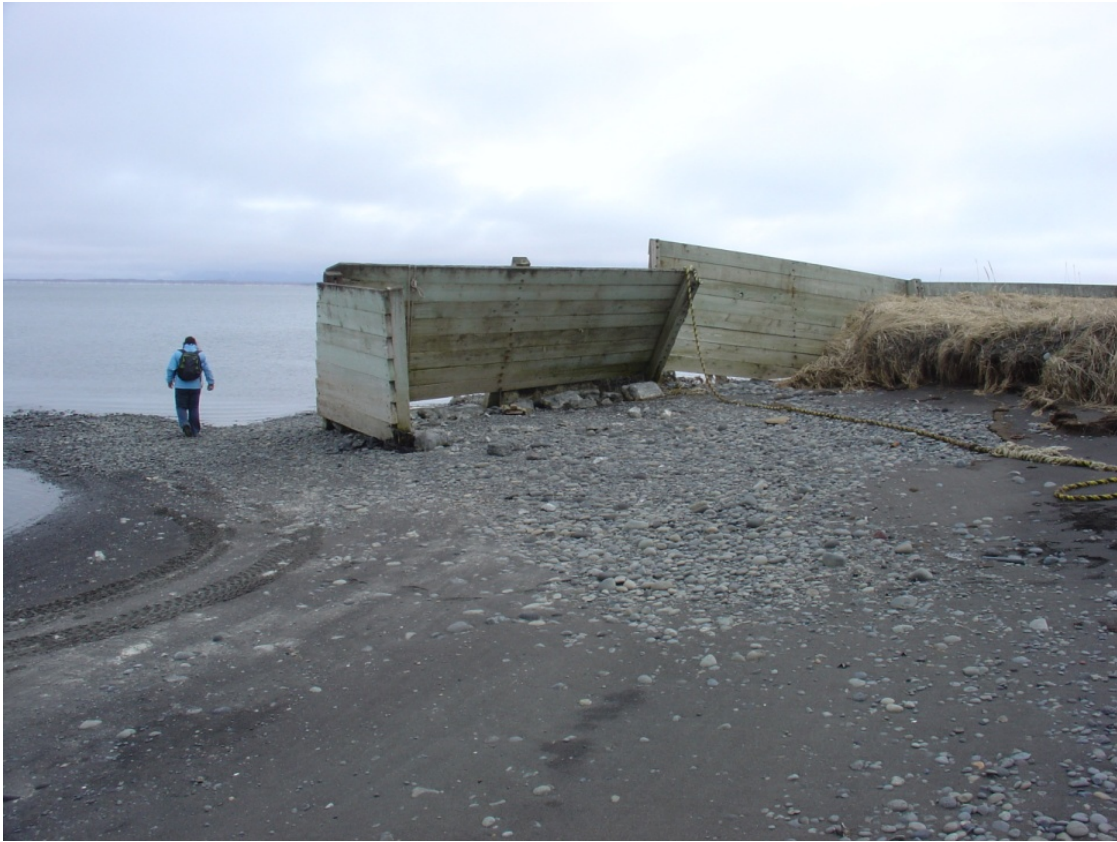
Community members also noted that the lateral supports placed on the outside portion of the wall that provide bracing were subject to damage from spring ice flows. Near the eastern edge of the timber sea wall, the earth behind the wall has been completely eroded (Figure 20).

**Figure 20. Severe Erosion of Wooden Sea Wall on Eastern End of the Wall**

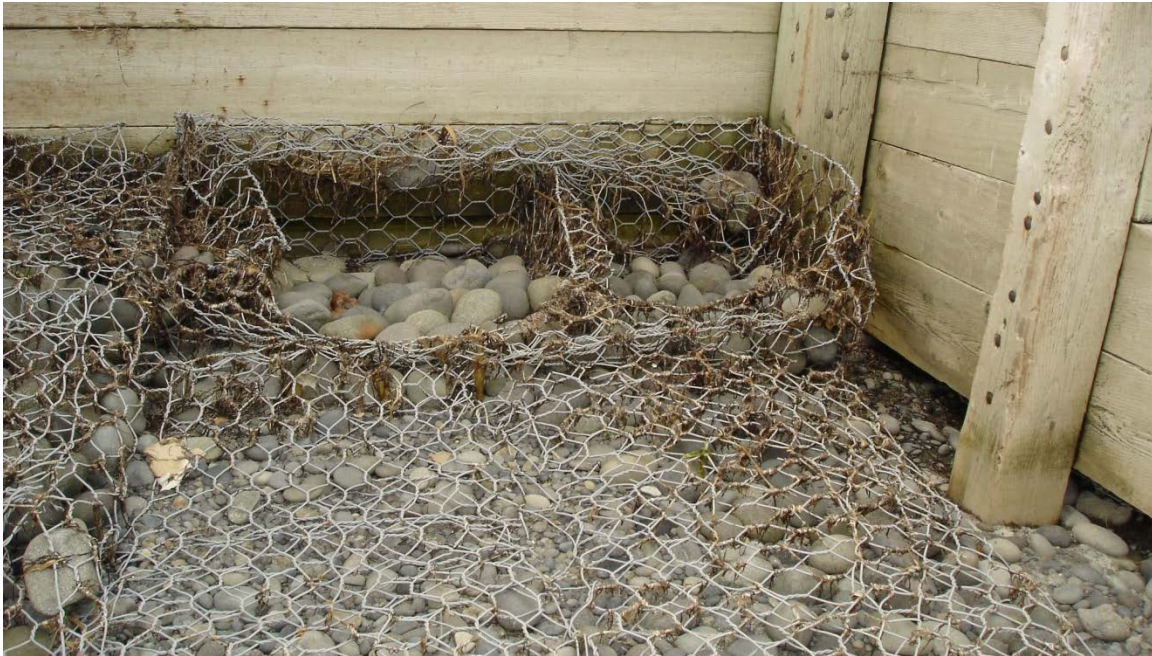
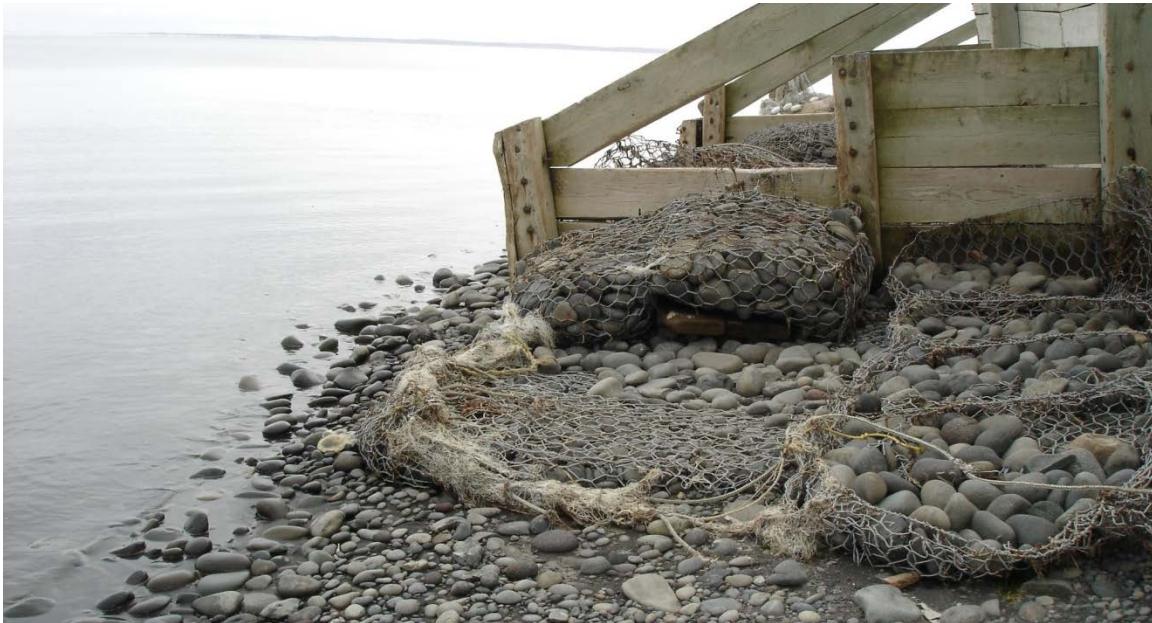
In 1986, gabions (wire mesh cages containing rocks that are used to absorb some of the wave energy) were added to anchor the existing wood seawall (Figure 21 and Figure 22). This project cost approximately \$60,000 and is reported to have had little success because of tides and high winds (USACE 2007). According to AEB, the rocks were undersized compared to the gabion mesh, resulting in the rocks eventually being washed away (U.S. Senate 2004).

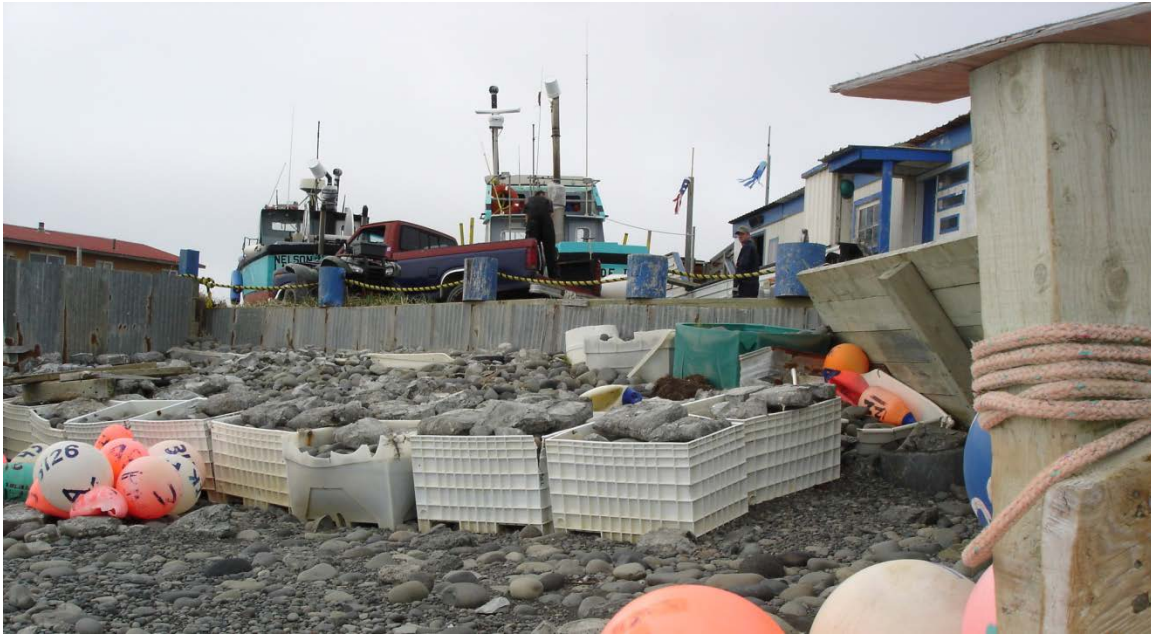
Residents have attempted to utilize available materials to help stabilize the wall and protect it from erosion, including nets, plastic totes filled with cobbles and chunks of concrete, engine blocks, and metal debris. One homeowner has used rock-filled fish totes to help reinforce the wooden seawall and protect his property from further erosion (Figure 23).

Figure 23. Rock-Filled Fish Totes Used to Reinforce the Wooden Seawall

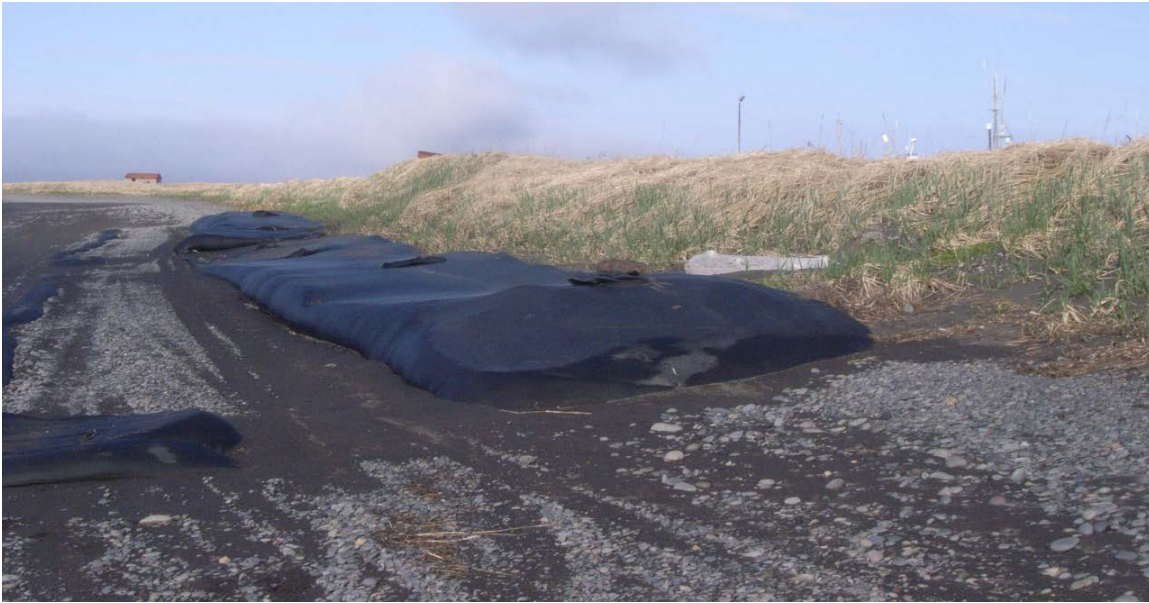
In September 2005, a geotube containment structure, consisting of a sediment-filled sleeve of geotextile fabric, was installed near the city dock (Figure 24). According to the USACE (2007), the finished structure consists of approximately 300 linear feet of geotube that is five feet high with a 7.5 foot scour apron. The USACE reported that when they prepared their document, there had not been enough time to assess the structure's effectiveness. Based on a visual inspection during the May 2011 community visit, the tubes were observed to be in good condition. It was not possible to assess the impact of the geotubes when we made our observations, as we did not have a good basis of initial conditions for the erosion protection and the corresponding control area. However, it did appear that the vegetation extended one to three feet farther in the middle of the tube section relative to the ends, a possible indication the tubes were working. Community residents also indicated that the project has slowed erosion in the area. No quantifiable measurements were available to determine the effectiveness of this project.

Figure 24. Geotube Containment Structure

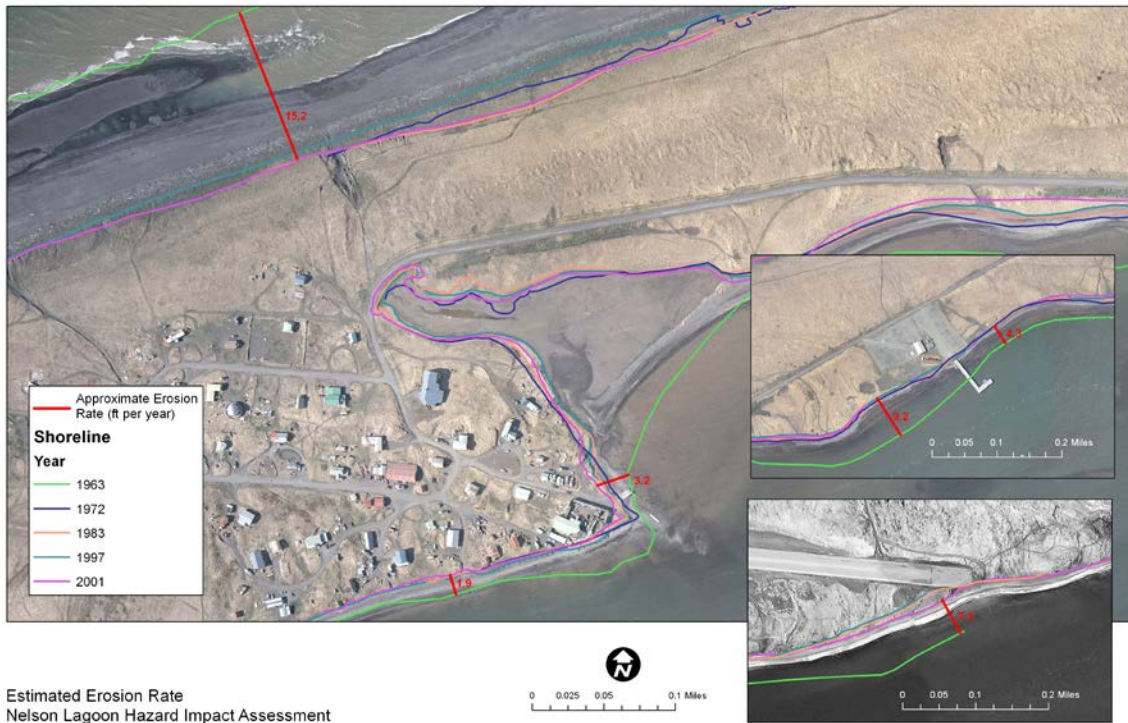
In Nelson Lagoon, the beach area historically tends to wash out in one area and then rebuild in another. The active erosion area along the Nelson Lagoon side of the spit is less than 100 feet from community structures, including housing and the runway. According to the USACE, major erosion events in the community have been constant for the last 20 years, resulting in an average of five feet per year of shoreline erosion (USACE 2007). Along the spit, erosion occurs at an approximate rate of one to two feet per year, per the USACE Erosion Information Paper; however, no specific measurements of extent were provided. In 2009, historical shoreline mapping was done by digitizing shorelines from the 1963 USGS quadrangle map and aerial photography from 1972, 1983, 1997, and 2001. Based on this historical shoreline mapping, erosion rates at various points along the shoreline were approximated. The results are shown in Figure 25.

Figure 25. Approximate Erosion Rates

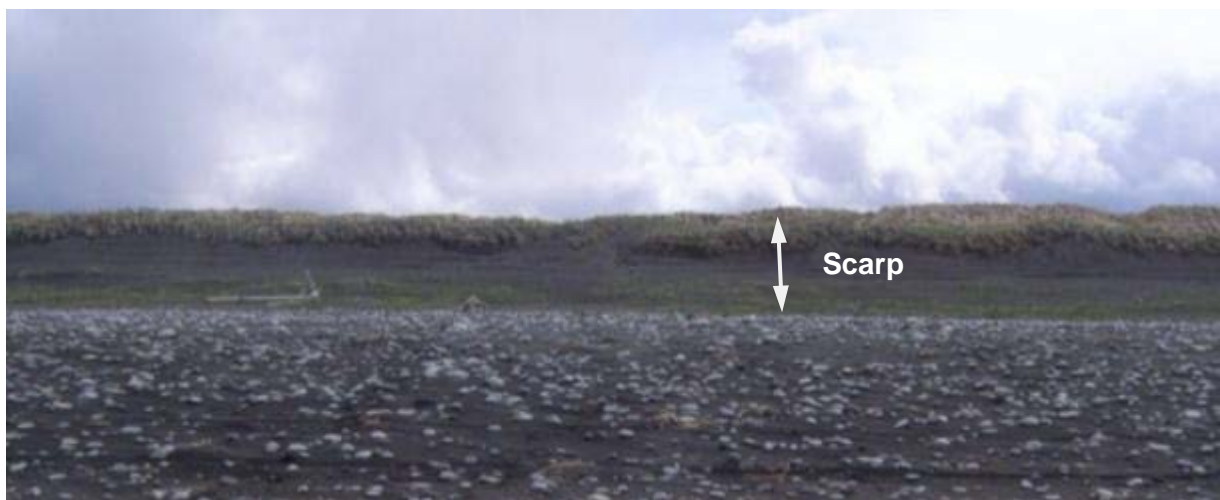
Figure 28. Bering Sea Shoreline (Facing Landward)

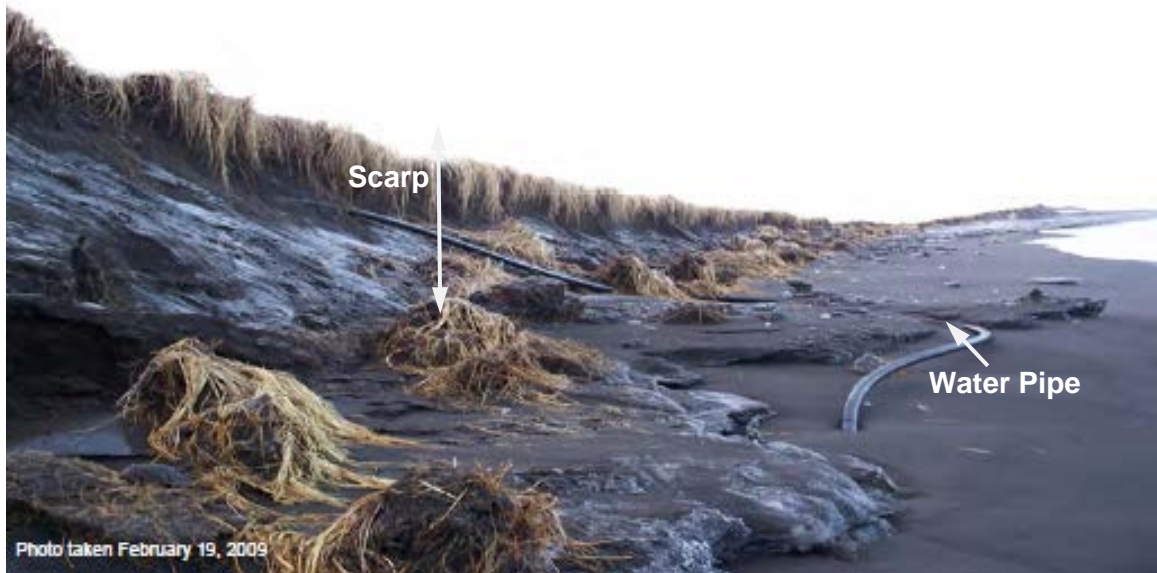
Figure 29. Bering Sea Shoreline Erosion (HDR 2010b; Notice exposed water transmission pipe)
