**US Army Corps of Engineers
Alaska District
Soils and Geology Section**

PRELIMINARY GEOTECHNICAL OVERVIEW
Village Relocation Site
Newtok, Alaska

November 2002

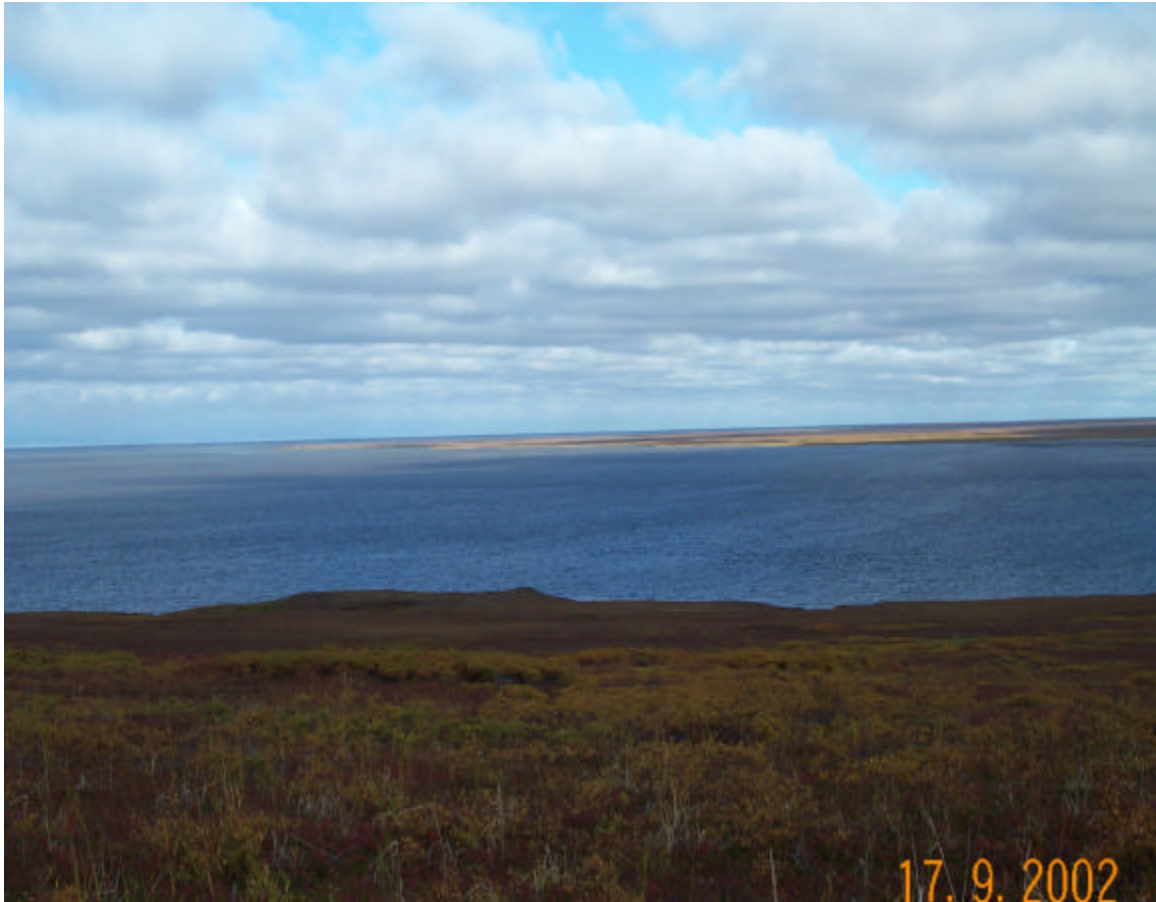
Photo 3. Looking north from the middle of the relocation site.

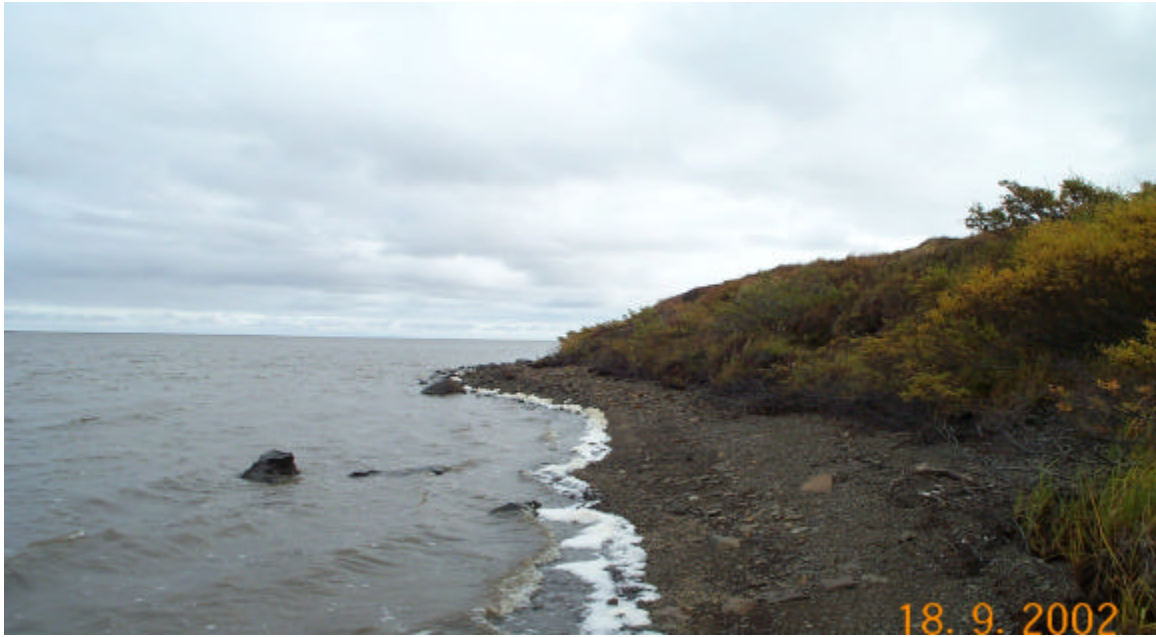
Findings While at the site, the tide was observed to fluctuate about four feet. The western three-quarters of the beach area at the site have mud flats exposed during low tide or very shallow water (generally one foot or less). The eastern quarter of the site has relatively deep water near shore. The main river channel is adjacent to the beach in this area. No measurements of the water depth were made. Boulders to two feet are scattered in the tidal zone throughout the beach in the entire area. There are isolated areas of sand and gravel, but most of the beach is surfaced with a layer of angular basalt cobbles and boulders to 15 inches. Conducting hand probes along the beach indicated that the cobbles and boulders are surficial and underlain by low-plasticity, fine-grained soils. There is evidence along the beach bluff of sloughing of the adjacent uplands area. In

most areas, the beach bluff is about 10 to 20 feet high having a slope generally at an angle of about 30 to 45 degrees.

Photo 4. Beach area at the proposed barge-landing.

Barge Landing The area at the proposed barge landing will be investigated by drilling one test boring to a depth of 20 feet on the beach. It is anticipated that some type structure (probably rock or rock-filled) will be required for the barge to pull up to and tie-off. Also, it is anticipated that in addition to building a head-structure at the beach it will be necessary to remove the scattered boulders in the tidal zone. It will also be necessary to remove the boulders within the adjacent beach area that will be used by the residents as a landing area for their boats. A study needs to be performed at the barge-landing site to determine the water depths in the area.

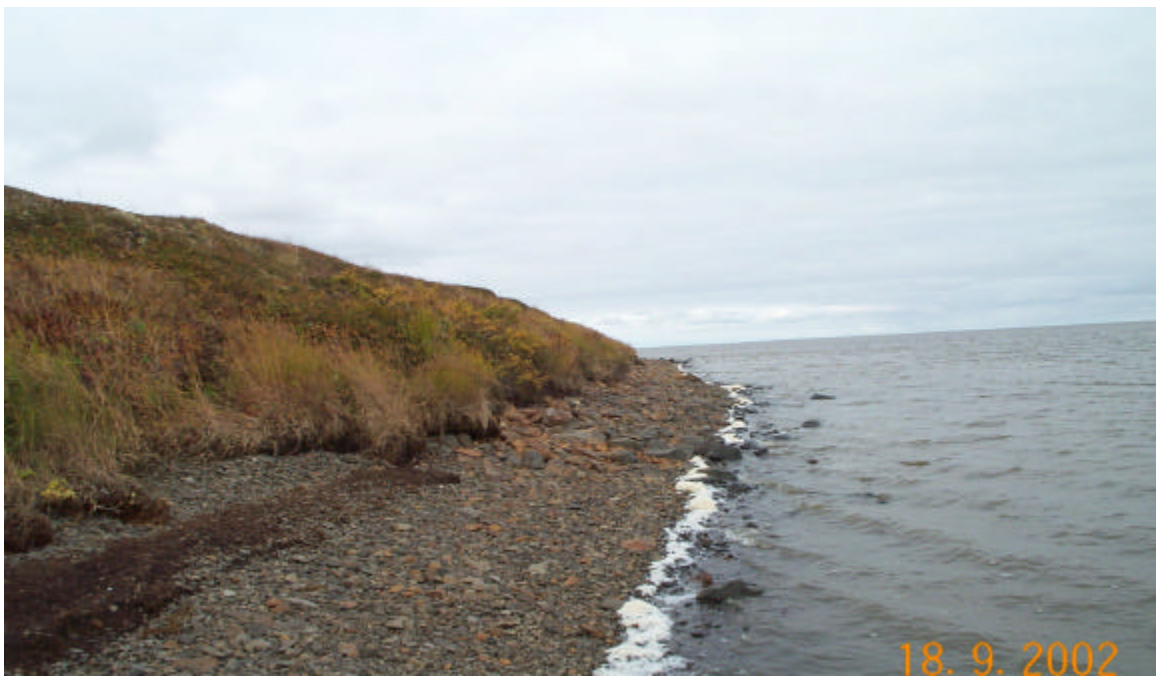
Photo 5. Beach area near the barge-landing site.

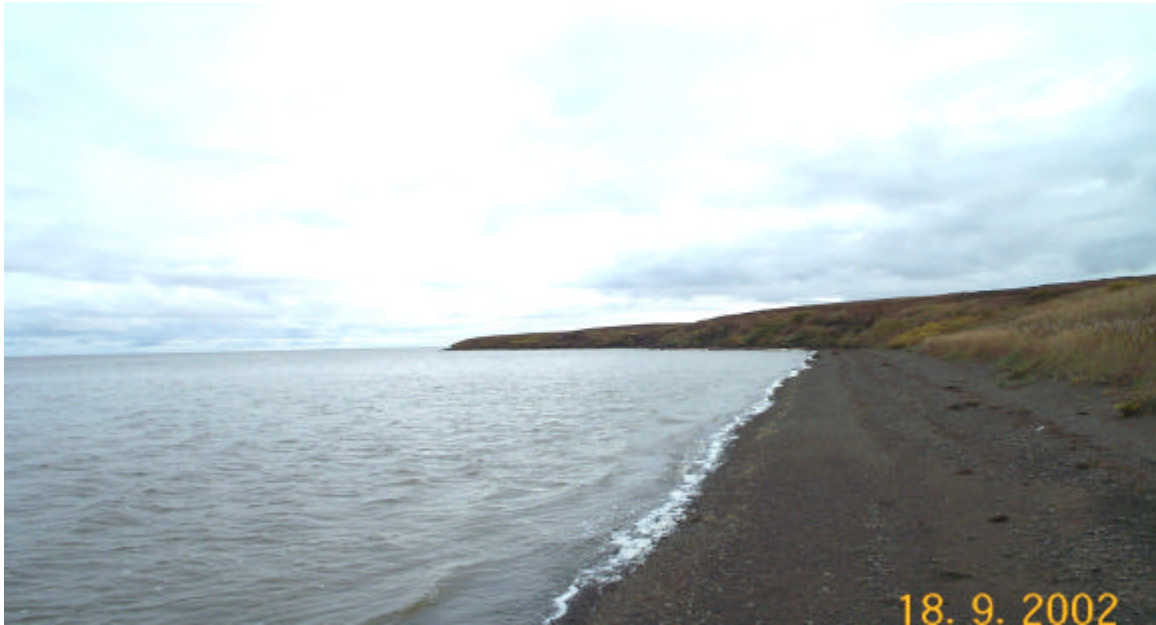
Photo 6. Beach area west of the barge-landing site.

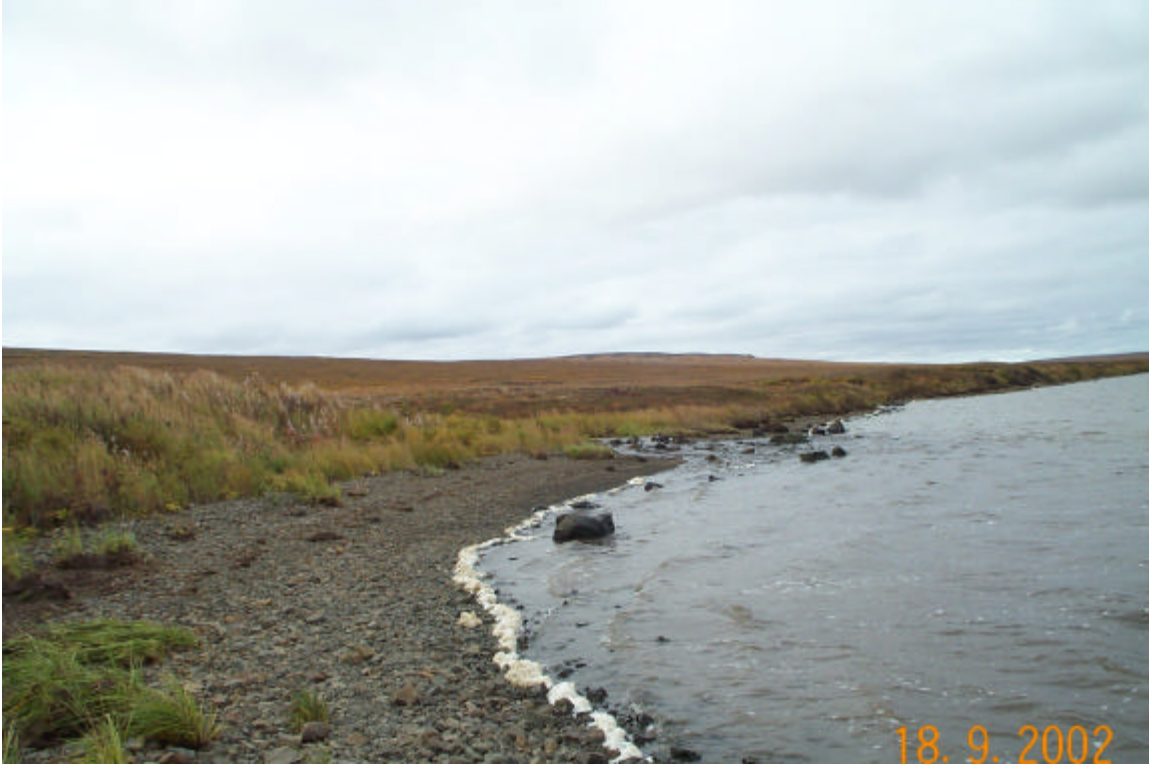
Photo 7. Mouth of drainage (spring) just north of the village site.

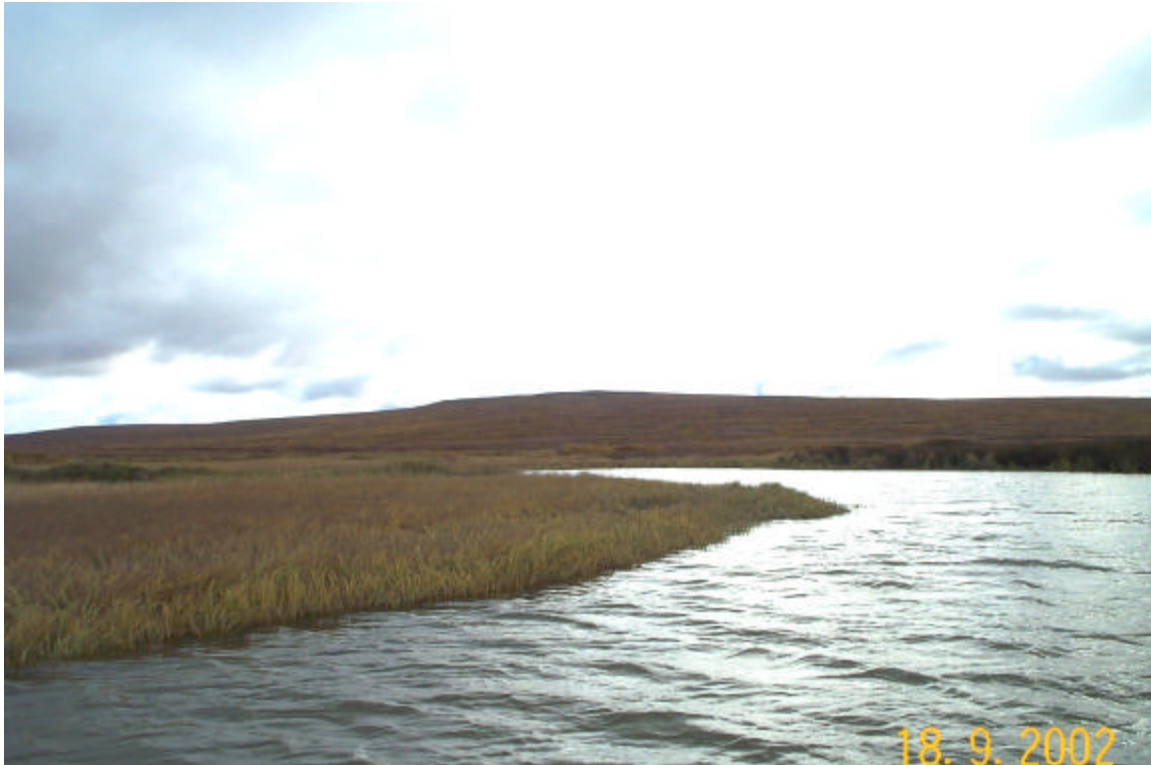
The creek at the west end of the relocation site was visually inspected. It was estimated that the flow in the creek, at the time of the reconnaissance, was about 1200 cubic feet per second. This is only an estimate based on a relatively uniform cross-section and timing the rate at which a floating object passed through the cross-section. It is probable that the flow volumes in the creek are less in mid-winter than during the time when the reconnaissance was performed. It should be noted that the creek had many Coho salmon and some Dolly Varden present at the time of the reconnaissance. The residents of Newtok report that Pink salmon also spawn in the creek. The lower portion of the creek is tidally influenced and has meanders over a relatively wide area. It will be necessary to determine the area of tidal influence and locate the water infiltration gallery above that area. It will also be necessary to locate the infiltration gallery in an area where the creek is confined to a single channel. Hand probing the channel indicates that the creek bottom

is composed of gravel and sand. However, the probing extended only to a depth of about 18 inches.

Photo 8. Mouth of creek at high tide.

Water Infiltration Gallery The water infiltration gallery should be sited as far upstream as feasible. It is critical that the site be upstream of the tidal zone and not located in a multi-channeled area. The location shown on the current plan appears to meet these criteria, but the final location should be selected in the field. The estimated flow volume in the creek at the time the reconnaissance was performed was about 1200 cubic feet per second, but lower flow rates probably occur during mid to late winter. Knowledge of periodic flow volumes is important. It is recommended that the flow volumes be measured with a system that will allow an accurate measurement during the winter lows. This will be important when applying for permits to install the gallery. Alaska Fish and Game and the U.S. Fish and Wildlife personnel will be interested in the percentage of flow that will be diverted to the village and the potential impact on the salmon spawning and survival characteristics of the creek.

The subsurface condition that is critical for the infiltration gallery to properly function is a sufficient depth of alluvial material under the creek. This will protect the gallery from freezing and scour. The material also should be permeable enough for the gallery to gather sufficient water. To determine these characteristics, it is recommended that one boring be drilled to a depth of 20 feet on each side of the creek (at the waters edge). Drilling in the creek will not be allowed and no discharge or cuttings from the borings should enter the creek. Samples from the borings will be tested to determine the grain-size distribution of the material present. This will be used to design the gallery length, diameter, and slot size.

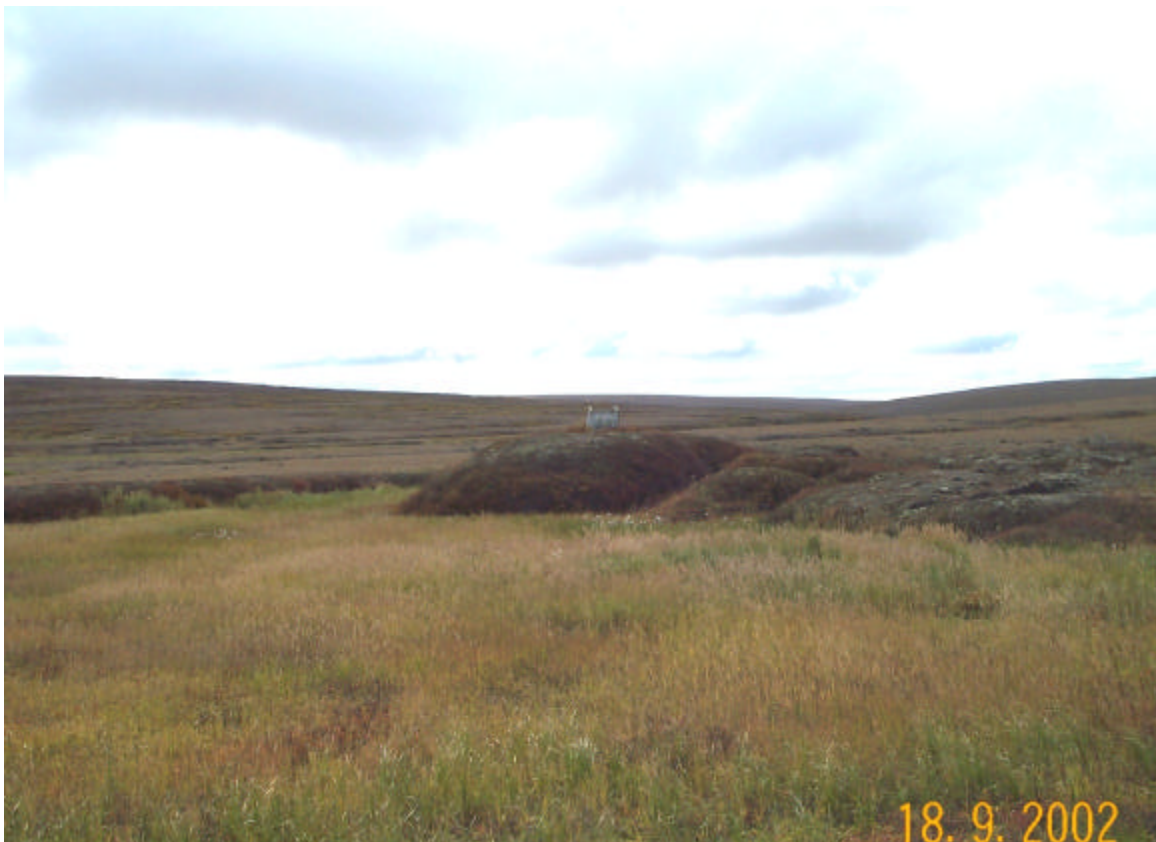
Photo 9. Grave on the west side of the creek near the mouth. Potential airport location in the background.

Airport The proposed airport needs to be relocated to another area of the site and reoriented to a north/south direction. The final orientation will be dependant on wind direction data gathered by the Alaska Department of Transportation prior to final design. The observations made and local reports indicate that the airport should be at as low an elevation as possible to limit foggy conditions. Another concern raised by the U.S. Fish

and Wildlife Service is that the island northwest of the creek mouth is a major nesting area for Black Brant. Any airport orientation should avoid over-flights of this area during landings and takeoffs. While there may be other suitable sites for the airport, the area parallel to the creek is considered a potential site. It is recommended that three test borings be drilled on each side of the creek to a depth of 20 feet to investigate subsurface conditions. Samples obtained from the borings should be tested to determine the general classification and physical characteristics of the soils encountered. These six test borings will provide preliminary information to be supplemented with additional borings after the final location and orientation of the airport has been selected.
