# Nelson Lagoon Hazard Impact Assessment

Prepared For:

HDR Alaska, Inc.  
with  
Shannon & Wilson

October 2011

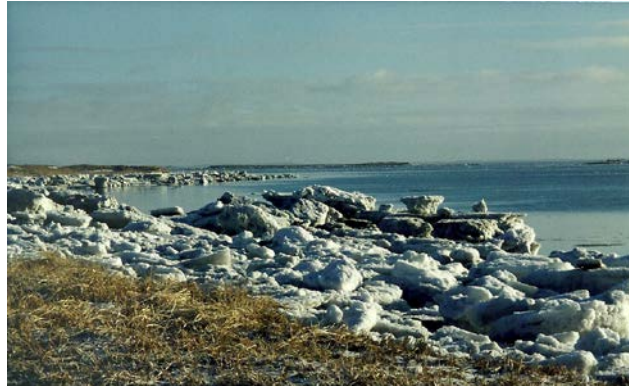
Figure 4. Ice along Shoreline in 1997

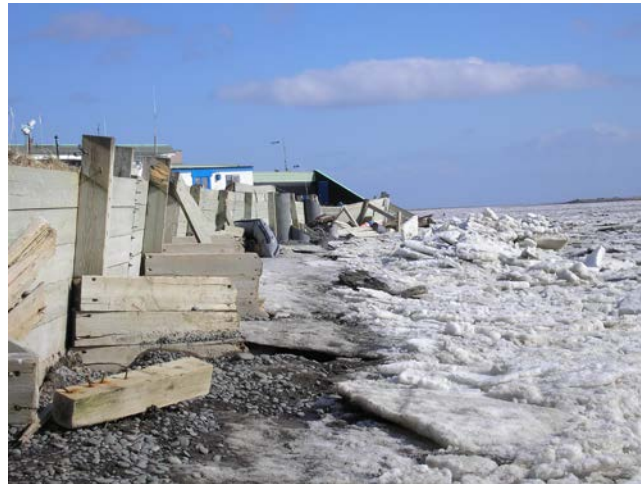
Figure 5. Ice along Shoreline in 1995

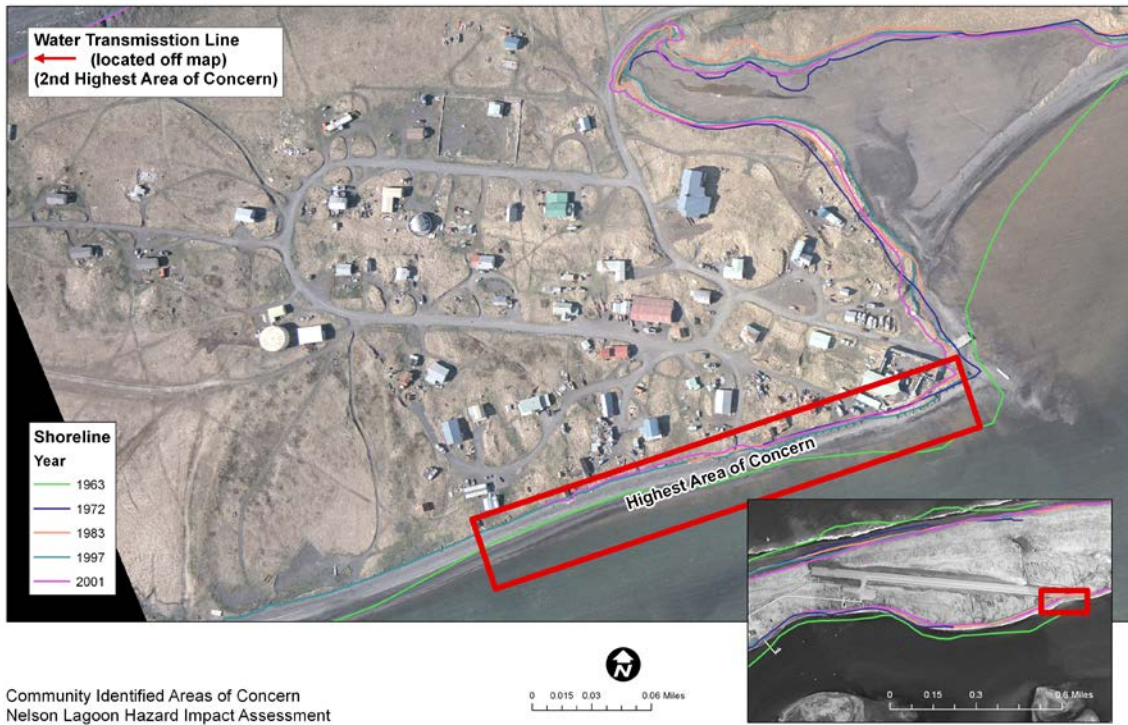
During the first site visit, Laurie Cummings with HDR Alaska and Eric Anderson with Shannon & Wilson met with members of the community. They talked about areas of Nelson Lagoon that have been impacted by hazards over time. The areas of concern to community residents are shown on Figure 16.

Figure 16. Community-Identified Areas of Concern

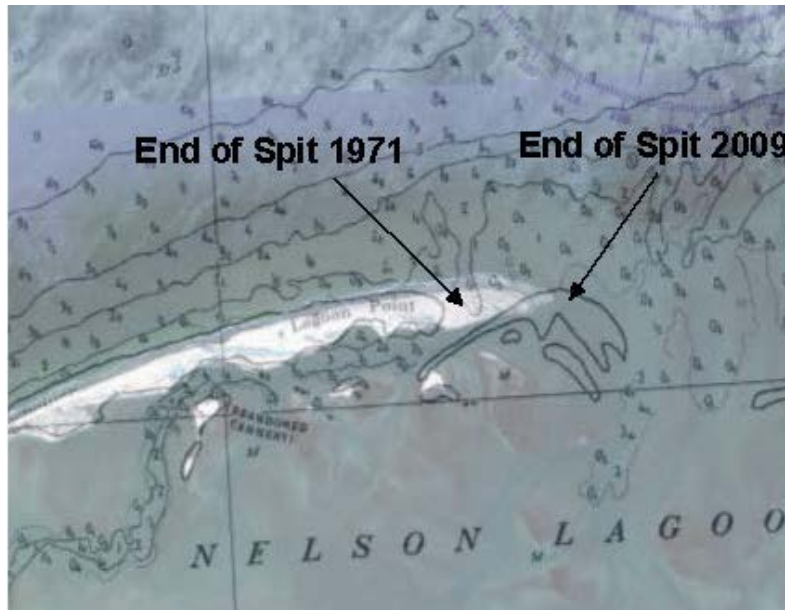
The direction of spit growth is consistent with the predominant offshore wave direction as shown in Figure 13 and Figure 14. Given enough time and updrift sediment supply, spits can continue to grow and may eventually evolve into larger land features such as barrier peninsulas or islands. When comparing a 1971 T-Sheet and recent aerial photography, it appears the Nelson Lagoon spit is lengthening at a rate of approximately 140 feet/year (Figure 27). According to anecdotal data presented by Cordova et al. (2010), the spit has grown 1.5 miles in the past 50 years, equating to 160 feet/year. It should be noted that if the supply of sediment is no longer available or is reduced, the spit can dwindle in size, growing longer and thinner until it is completely breached and broken up by waves. USACE (2007) reported the spit is "...getting longer and narrower as erosion advances on both sides." Depletion of updrift sediment supply at Nelson Lagoon could potentially be catastrophic in the long term. A detailed assessment of updrift sediment supply and overall sediment budget will be important for prediction of future morphology of the spit.

Figure 27. 1971 T-Sheet Overlaid on a 2009 Aerial Photograph (Notice approximate 1 mile extension of spit - ~140 ft/year)

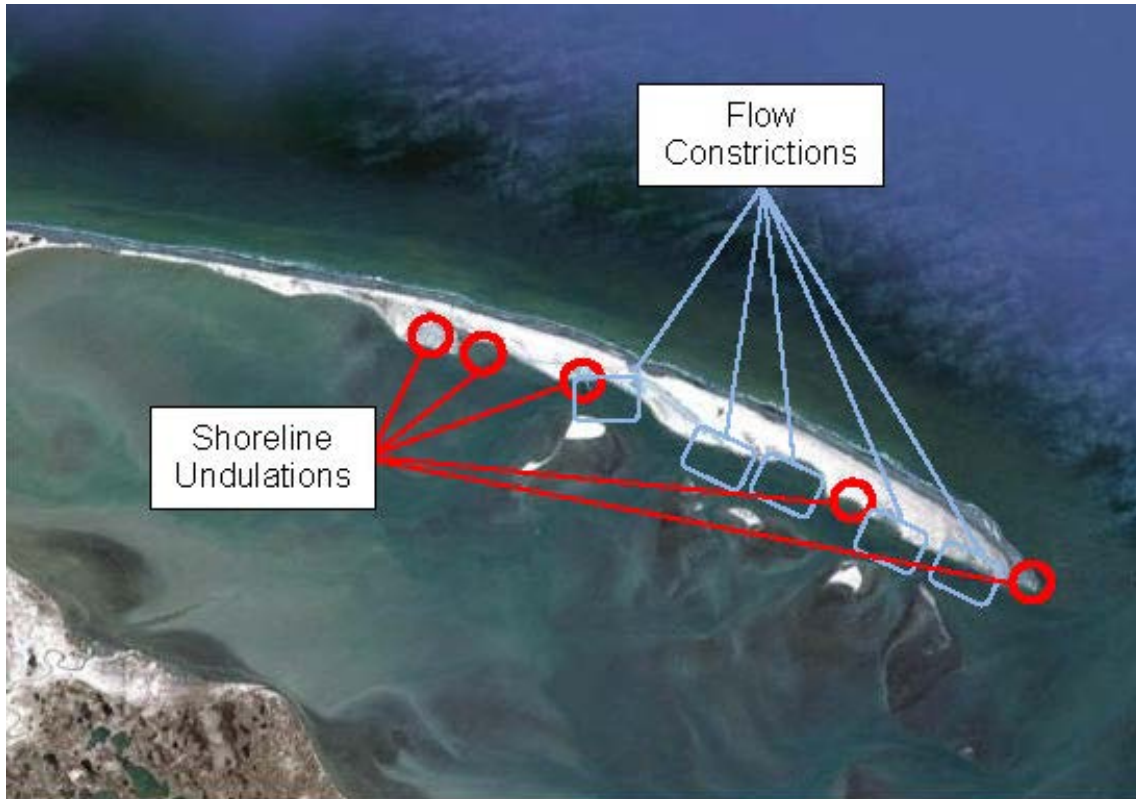
In addition to waves, tidal currents were considered a mechanism for erosion along the bay shoreline of Nelson Lagoon. Various geometries of a bay, such as sharp undulations in the shoreline, abrupt changes in water depth, and focusing or narrowing of the water body, can constrict and/or amplify tidal currents. Figure 30 shows potential areas where this might occur in Nelson Lagoon. Changes in water depth were not evaluated due to lack of bathymetry for this area. More detailed hydrodynamic analysis within Nelson Lagoon would help identify areas of increased tidal current and potential erosion hotspots.

Figure 30. Potential Areas of Amplified Tidal Currents
